US Army Corps
of Engineers

USACERL Technical Report 95/02
May 1995

Thermal Energy Supply Optimization for Aberdeen Proving Ground-Edgewood Area

Distribution System Condition Assessment and Recommendations

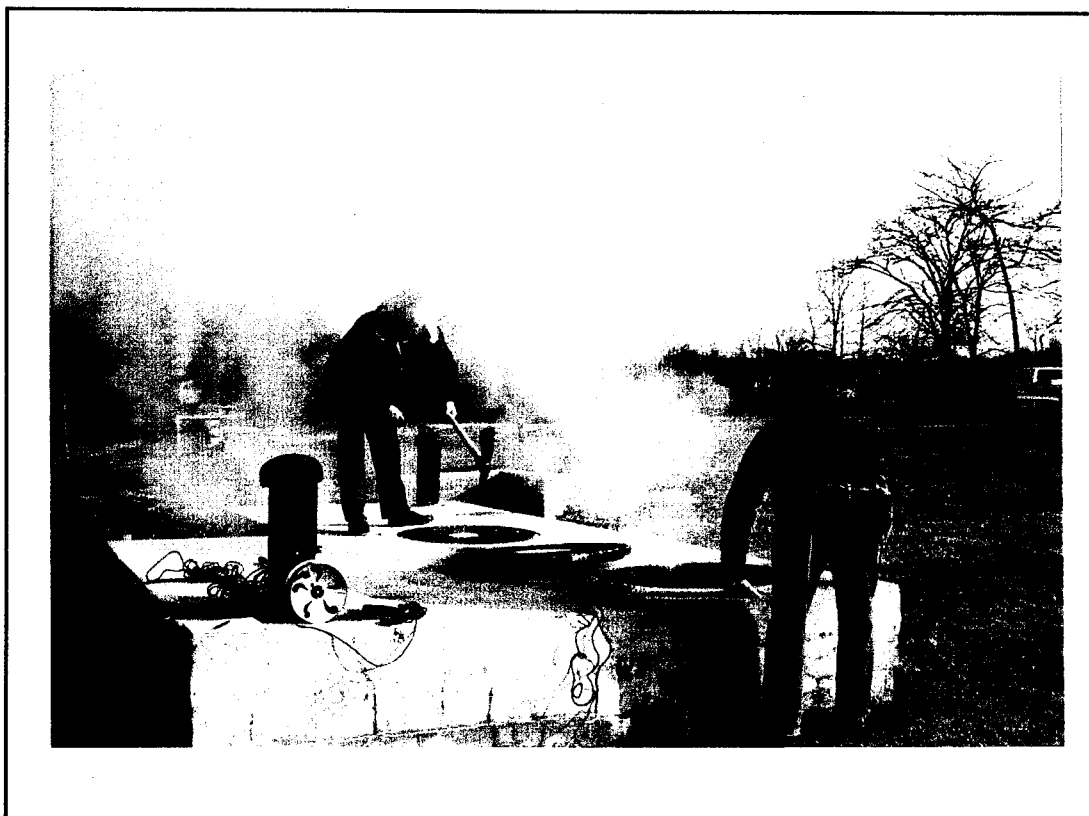
Figure 15. Typical steaming manhole (no. 5220) with standing water.

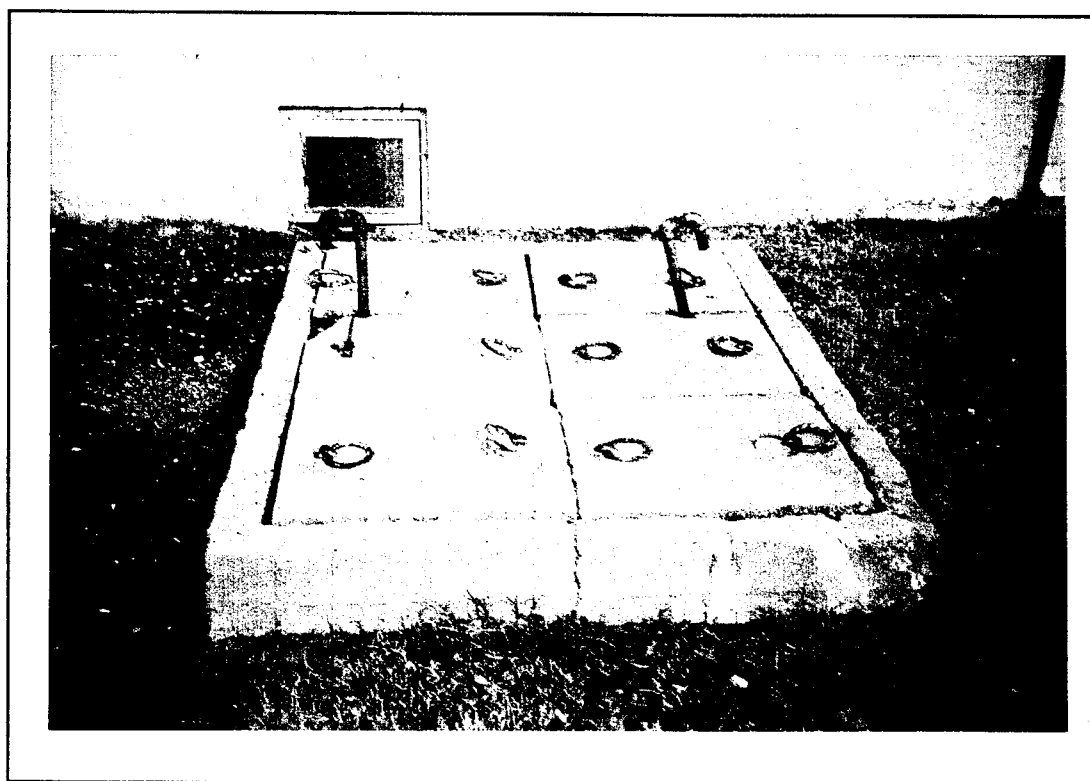
One manhole with an excessively heavy concrete manhole cover was observed (Figure 22). Such manhole covers make it very difficult to perform maintenance or inspections in the manhole.

Figure 22. Excessively heavy concrete manhole cover in the 4000 area.
